Profile

ROBINSONS·MAY

Challenge *Aged Hypalon® Roof*

Solution *AcryShield® Restoration System*

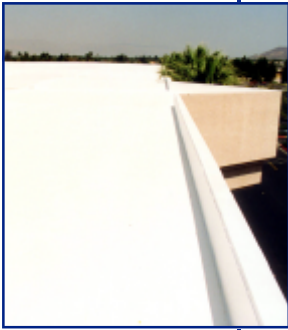
- Aging Hypalon.
- Intense desert UV attack.
- Active retail site.

AcryShield Restoration Systems are an excellent option to extending the leak-free life of weathered Hypalon showing chalking, exposed scrim, checking and other signs of UV accelerated polymer degradation.

- Seam repair and reinforcing.
- Maintained Cool Roof surface with UV resistant coating.
- Clean and compact job site staging.
