Profile

SEARS WAREHOUSE

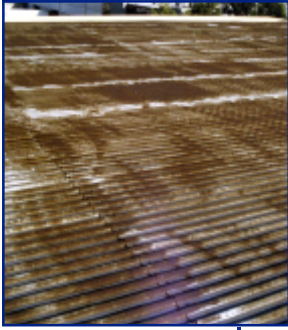
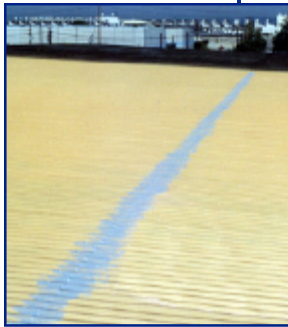
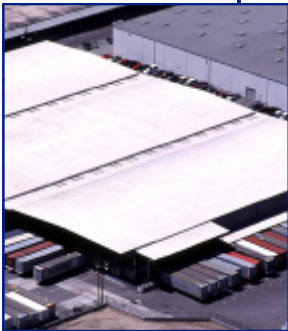
Challenge *Leaking & Corroding Metal Roof*

- Leaks at seams & fasteners.
- Mounting surface corrosion.
- Uncomfortable warehouse during summer.

Solution *AcryShield® Restoration System*

- Rust-inhibitive primer system.
- Reinforced seams & fasteners.
- Reduced summertime surface temperatures by 50°F.

Sears chose a Cool Roof restoration system to solve typical metal roof leak problems and to eliminate excess heat stress due to the intrinsic low heat release properties of bare metal and aluminum coated roofs.
