*Profile*

# Sequoia Pacific Systems

*Size: 340,000 Square Feet*

*Location: Exeter, California*

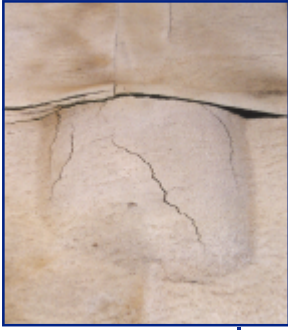
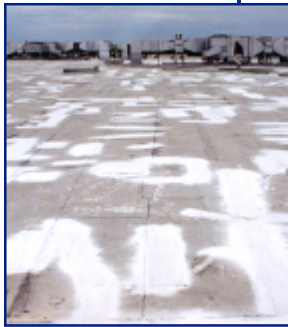
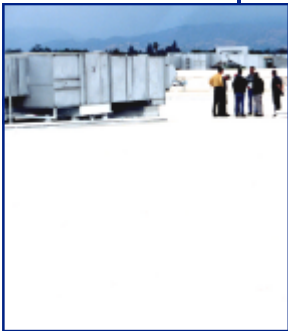
## **Challenge** *SBS Mod Bit Blistering*

- Severe membrane blistering and ridging.
- Ongoing thermal shock and stress.
- Major leak repairs expected.

## **Solution** *AcryShield® Restoration System*

- Reinforced blister repairs.
- No excess thermal shock.
- 10-15% energy savings.
- Avoided re-roof and saved valuable insulation.
